Property Inspection Report Of  
123 Mission Oak Drive, Lithia, FL, 33547

Prepared For  
Home Buyer

On  
Friday, August 04, 2006

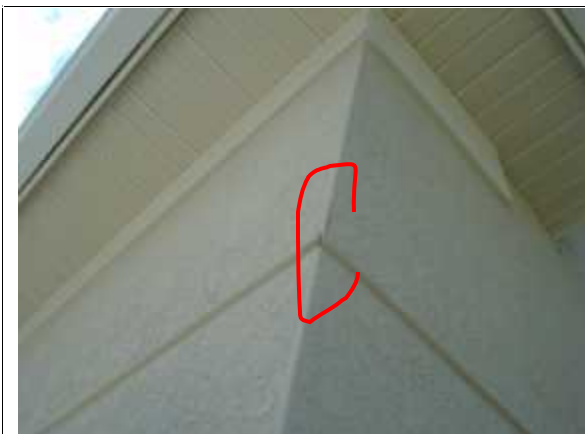
1. Typical hairline cracks in stucco

- ◇ Stucco has been applied over wood frame walls above the first floor. The stucco installation is consistent with local building practices; however, it is not compliant with nationally recognized standards. Noted areas of the stucco that are cracked. See photo 1. Also noted hairline cracks in the stucco about the window openings. Repair the stucco as necessary to insure a watertight installation. Caulk the window and door openings as necessary, as well as other areas, where hairline cracks may appear.

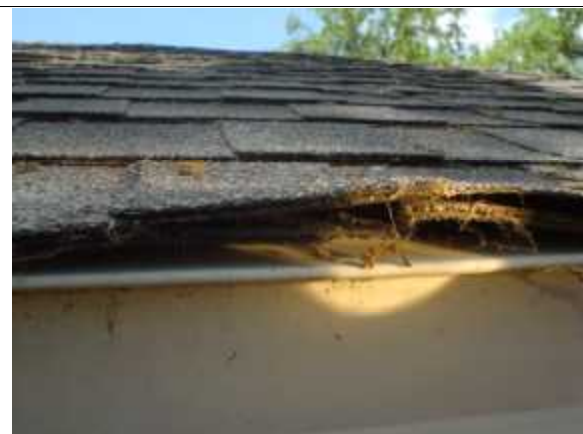
- ◆ Noted raised shingles at the rear left. See photo 2. A nail head is raised. Reset the nail, and seal the shingles to the drip cap.

2. Raised shingles, left rear

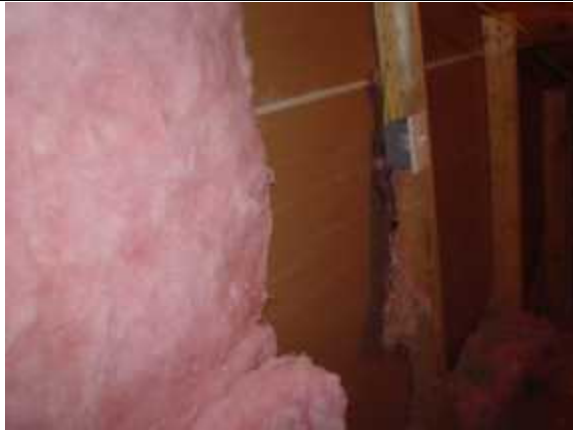
- ◆ Wall insulation is missing at the stairwell. See photo 3. Replace the insulation.

3. Missing wall insulation, stairwell

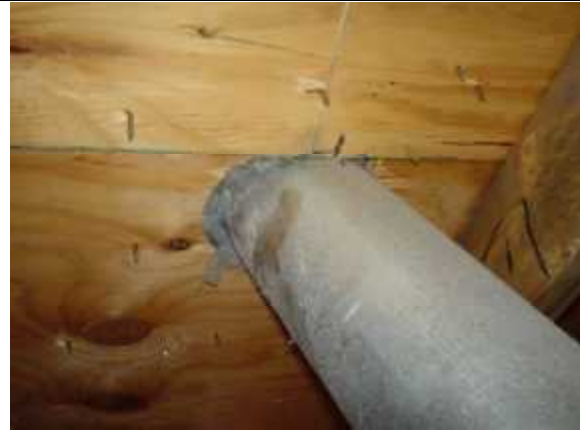
- ◆ The dryer vent appears clogged, where it passes through the roof decking. See photo 4. The vent should be cleaned.

4. Clogged dryer vent
