Property Inspection Report Of
14700 Gulf Boulevard, #XXX, Madiera Beach, FL, 33708

Prepared For
Mr. & Mrs. Buyer

On
Sunday, April 17, 2005

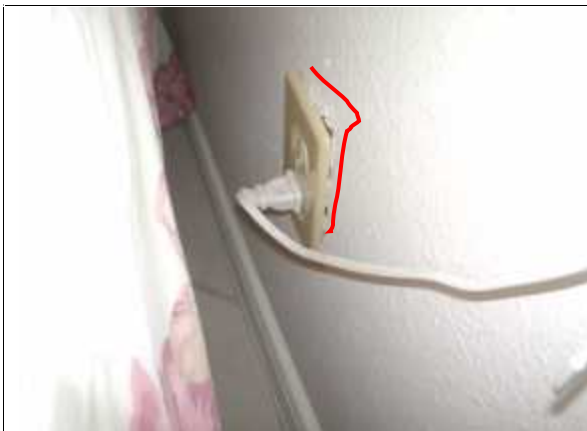
- ◆ One of the outlets in the front living room is loose. See photo 1. The outlet should be secured.
- ◆ The dimmer switch in the hall bath turns the light on and off, but does not dim the light. The dimmer may be damaged, or may not be compatible with the type of bulbs installed. Repair as necessary.
- ◆ The dimmer switch for the ceiling fixture in the dining area is damaged. When the switch was operated, a breaker in the main panel tripped. Further evaluate and repair as necessary.

1. Loose outlet at front sleeping room

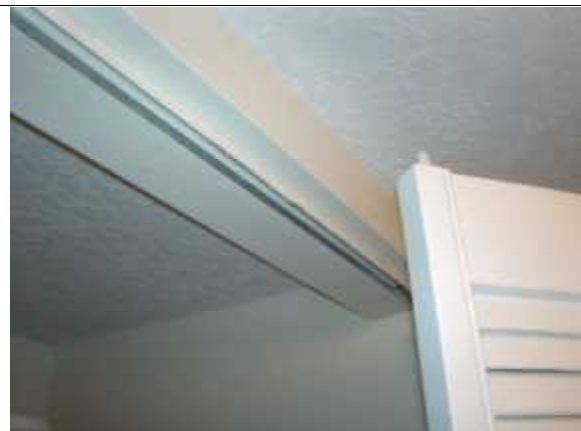
2. Laundry bi-fold door loose at overhead track

- ◇ The laundry bi-fold door is loose in the overhead track. See photo 2. A new track glide could be installed.
- ◇ The lock is damaged at the left rear sliding glass door. See photo 3. While security may not be a concern, the door should be able to be secured during stormy weather. Consider cutting a length of a clothes rod and placing it in the door track, or repair the lock.
- ◇ Smoke detectors are present, but are not installed in the bedrooms or other areas where detectors can be installed. Suggest upgrading the smoke detector installation with additional detectors in the bedrooms and other areas as necessary. Consult the smoke detector manufacturer's installation recommendations.

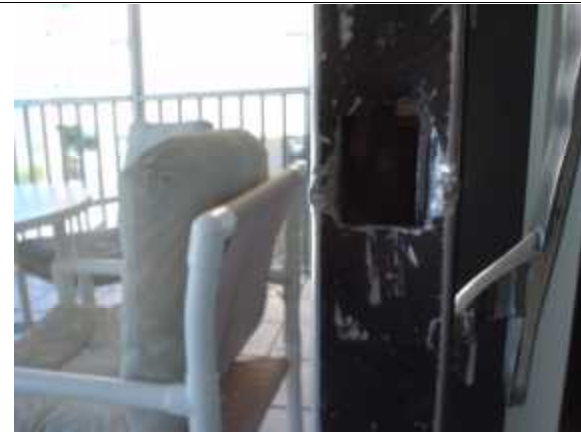
3. Damaged sliding glass door lock

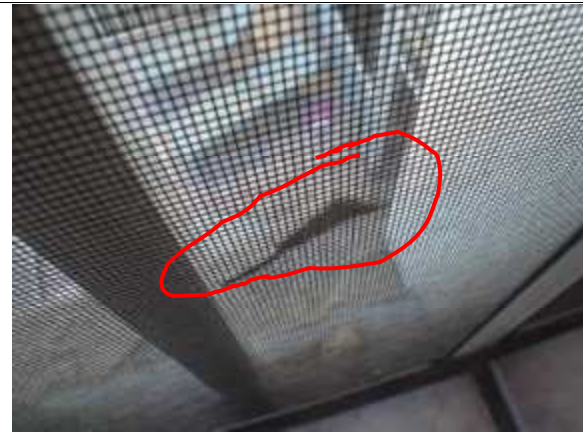
- ◆ Noted loose stucco at the right side of the terrace. See photos 4 and 6. Consult the owner's association and insure that the stucco will be repaired. Falling stucco is a significant life safety concern. Any metal behind the loose stucco should be cleaned and sealed before the stucco is repaired.

4. Loose & exposed stucco at right side of terrace

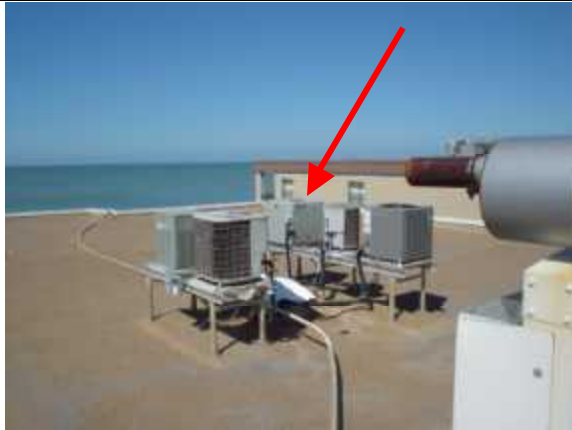
5. Location of rooftop AC

- Cooling is provided by an electric central air conditioner. The unit is installed on the rooftop. See photo 5 for the location of the equipment. The capacity rating is 2 tons, and the unit was manufactured in 2001. The accessible portions of the unit and the electric supply are in adequate condition, with any exceptions noted. Regular maintenance is advised.

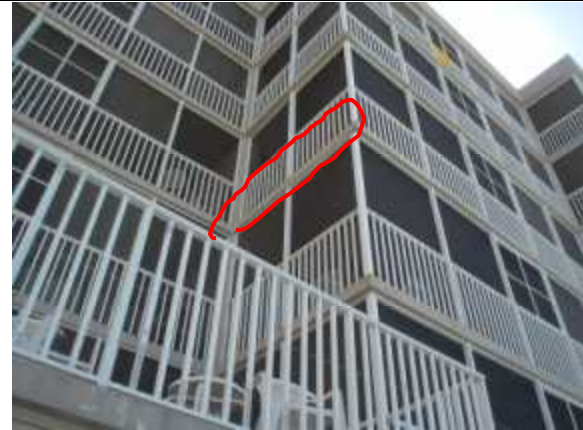
6. View from pool deck, damaged stucco
