Property Inspection Report Of
1234 3rd Avenue North, St. Petersburg, FL, 33713

Prepared For
Home Buyer

On
Monday, August 07, 2006

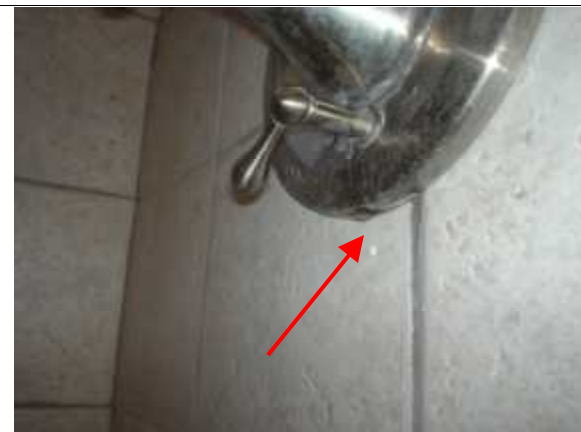
- ◆ The shower diverter is leaking and water is passing behind the wall into the wall cavity. See photos 1 and 2. Repair.

1. Leak at shower diverter

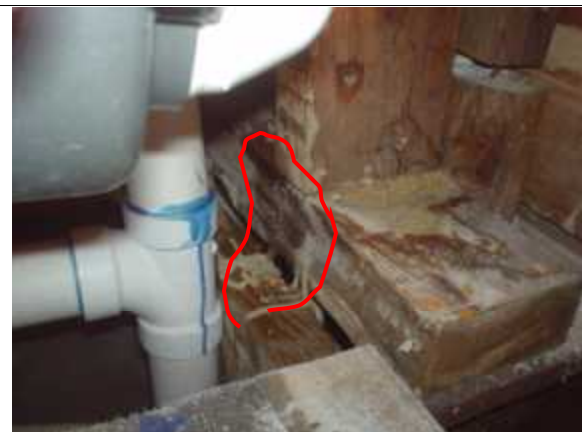
2. Water below tub from shower diverter leak

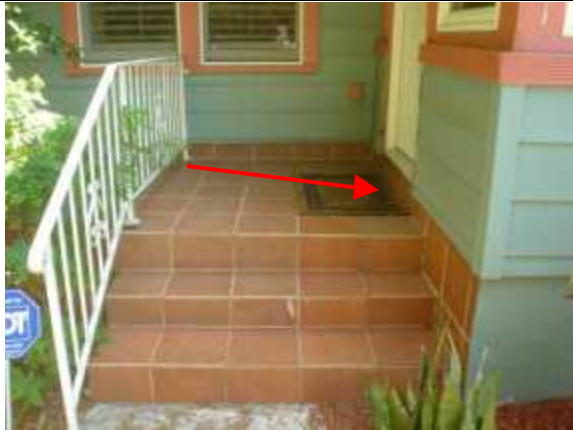
3. Monitor drainage at front stoop

- ◇ The front stoop may be reverse sloped, and water may collect below the door. See photo 3. Monitor.
- ◇ The railing is loose at the front stoop and could be secured.
- ◇ The door bell is not working and could be repaired.
- ◇ Portions of the exterior trim are somewhat water damaged and could be repaired.
- ◇ Typical cracks were noted in the masonry near the soil line along the exterior perimeter. The cracks could be sealed and monitored.

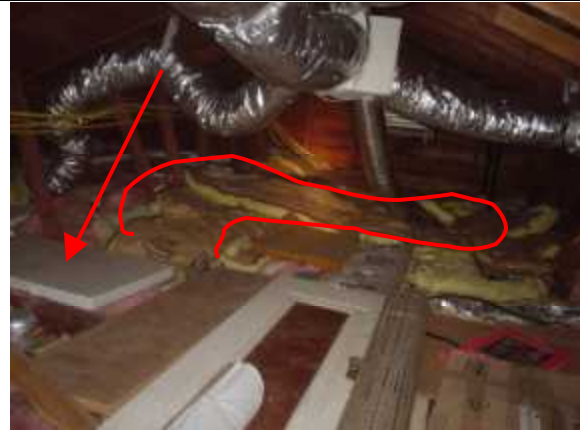
- ◆ Several attic insulation batts are installed upside down, with the flammable vapor barrier exposed. See photo 4. Remove the paper or flip the batts. Remove the Styrofoam stored in the attic, which will release toxic gases, should the Styrofoam burn.

4. Insulation batts upside down; Styrofoam in attic

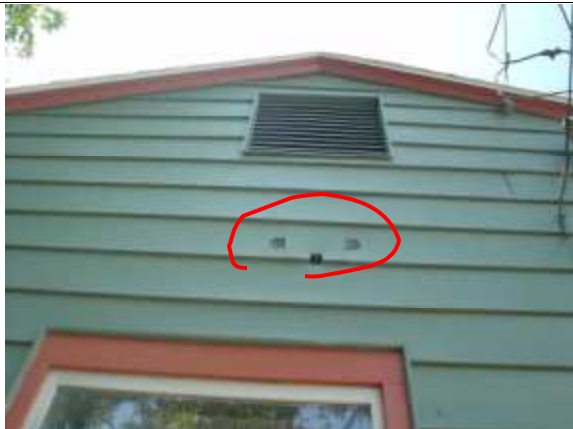
- ◆ Seal the openings at the rear exterior and terminate the electrical cable. See photo 5.
- ◆ Several of the crawl vent screens are missing and should be installed.

5. Exposed cladding and wire at rear
